**Flood Control Project Maintenance
Levee Inspections**

Maintenance Issue Types Only, Levee Inspection Report By Mile - Spring 2016

San Joaquin County Flood Control and Water Conservation District

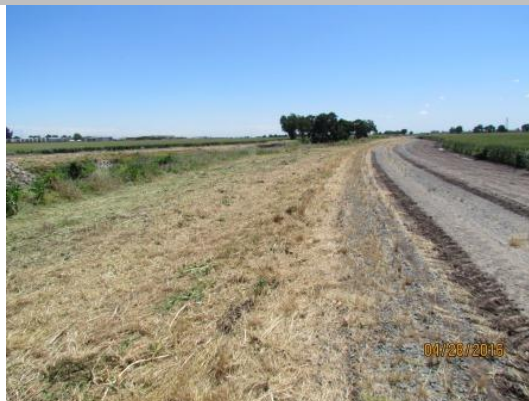
Photo 1 of 1 : SP_2016_NA0017_148_11_20160503_00025.jpg

LM Start	1.94	Rating **	A	Issue No.	11
LM End	1.94	Issue Type +	Ma	Location *	WS
Category	Earthen Levee			GPS Latitude/Longitude	
				Start	End
Item	Vegetation			37.887673 °	37.887673 °
				-121.256389 °	-121.256389 °
DWR ID	DWR_NA0017_01_s _ 2016_11				
Comment Code					
V1 : Control annual grass and weeds on the levee slopes and easements.					
Inspector Comment					
Acceptable vegetation.

View of the vegetation on the waterside of the levee looking upstream.

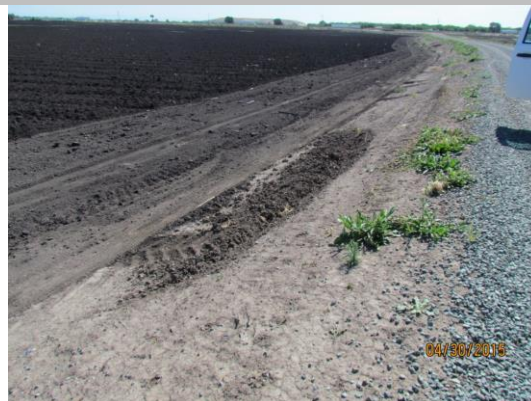
Photo 1 of 1 : SP_2016_NA0017_149_125_20160219_00008.jpg

LM Start	0.29	Rating **	M	Issue No.	125
LM End	0.29	Issue Type +	Ma	Location *	LS
Category	Earthen Levee			GPS Latitude/Longitude	
				Start	End
Item	Slope Stability			37.875189 °	37.875189 °
				-121.225048 °	-121.225048 °
DWR ID	DWR_NA0017_02_s_2015_125				
Comment Code					
S3 : Repair the levee slope damaged by vehicle traffic and prevent access where possible.					
Inspector Comment

A slope instability was found on the landside of the levee looking upstream.

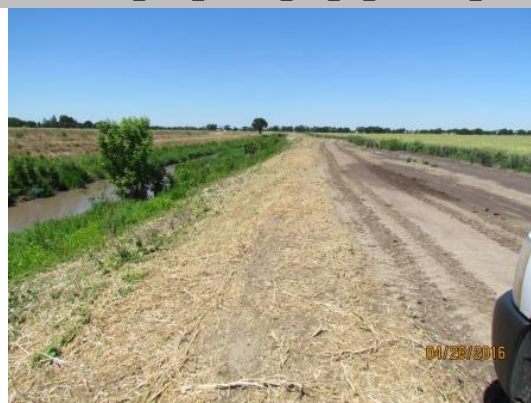
Photo 1 of 1 : SP_2016_NA0017_149_15_20160503_00027.jpg

LM Start	1.91	Rating **	A	Issue No.	15
LM End	1.91	Issue Type +	Ma	Location *	WS
Category	Earthen Levee			GPS Latitude/Longitude	
				Start	End
Item	Vegetation			37.881799 °	37.881799 °
				-121.249423 °	-121.249423 °
DWR ID	DWR_NA0017_02_s_2016_15				
Comment Code					
V1 : Control annual grass and weeds on the levee slopes and easements.					
Inspector Comment

View of the vegetation on the waterside of the levee looking downstream.

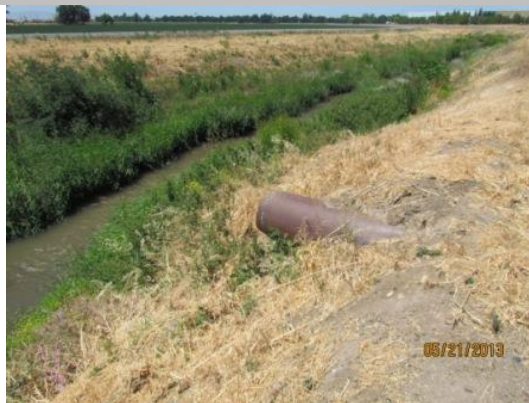
Photo 2 of 2 : SP_2016_NA0017_149_8_20160219_00005.jpg

LM Start	2.65	Rating **	A/W	Issue No.	8 (cont)	
LM End	2.65	Issue Type +	Ma	Location *	WS	
Category	Earthen Levee			GPS Latitude/Longitude		
				Start		End
Item	Encroachments			37.888853 °		37.888853 °
				-121.258640 °		-121.258640 °
DWR ID	DWR_NA0017_02_s_2012_8					
Comment Code						
PI : Pipe						
Inspector Comment						
Pipe crossing the channel has corroded and can carry water to/from the channel. A flap gate was installed by the LMA, but the pipe appeared to be damaged.

A pipe was found without a flap gate on waterside slope of the levee looking downstream. This pipe may predate the project.

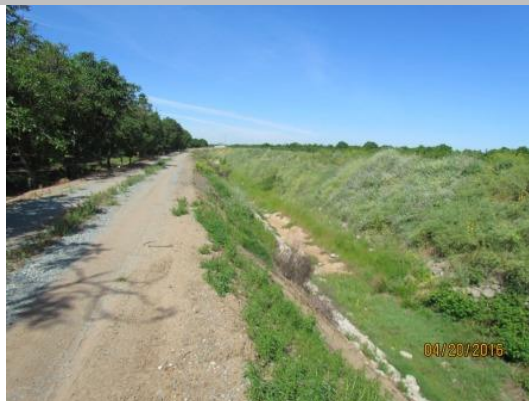
Photo 1 of 1 : SP_2016_NA0017_150_3_20160427_00006.jpg

LM Start	0.01	Rating **	M	Issue No.	3
LM End	0.21	Issue Type +	Ma	Location *	WS
Category	Earthen Levee			GPS Latitude/Longitude	
				Start	End
Item	Vegetation			37.979143 °	37.979256 °
				-121.098662 °	-121.095071 °
DWR ID	DWR_NA0017_06_s _ 2016_3				
Comment Code					
V1 : Control annual grass and weeds on the levee slopes and easements.					
Inspector Comment

View of the vegetation on the waterside slope of the levee.

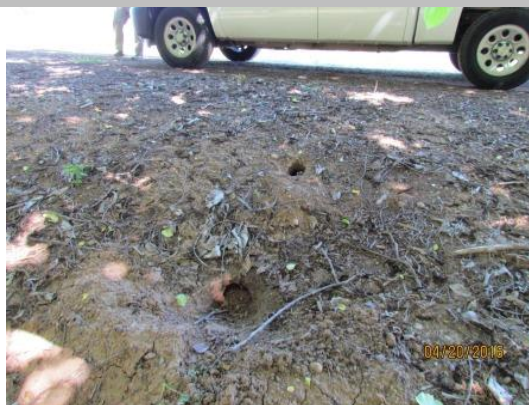
Photo 1 of 1 : SP_2016_NA0017_150_5_20160427_00007.jpg

LM Start	0.05	Rating **	M	Issue No.	5
LM End	0.05	Issue Type +	Ma	Location *	LS
Category	Earthen Levee			GPS Latitude/Longitude	
				Start	End
Item	Animal Control			37.979182 °	37.979182 °
				-121.097977 °	-121.097977 °
DWR ID	DWR_NA0017_06_s _ 2016_5				
Comment Code					
A3 : No rodents visible, but rodent burrows visible; need to backfill and compact or grout burrows.					
Inspector Comment

View of rodent holes on the landside of the levee.

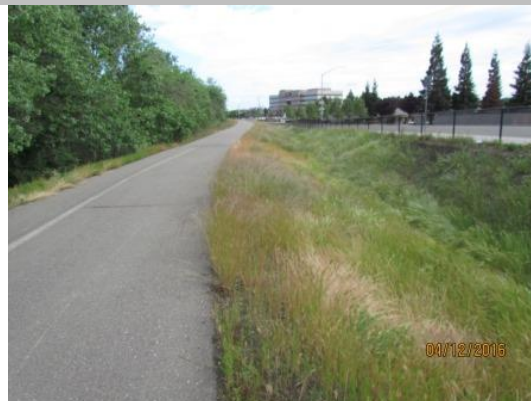
Photo 1 of 1 : SP_2016_NA0017_151_79_20160418_00147.jpg

LM Start	0.14	Rating **	M	Issue No.	79
LM End	0.14	Issue Type +	Ma	Location *	LS
Category	Earthen Levee			GPS Latitude/Longitude	
				Start	End
Item	Vegetation			38.043899 °	38.043899 °
				-121.370685 °	-121.370685 °
DWR ID	DWR_NA0017_07_s_2016_79				
Comment Code					
V1 : Control annual grass and weeds on the levee slopes and easements.					
Inspector Comment					
This portion of the levee is not maintained by the LMA, and this portion of the alignment runs perpendicular to Bear Creek.

View of the vegetation on the landside of the levee.

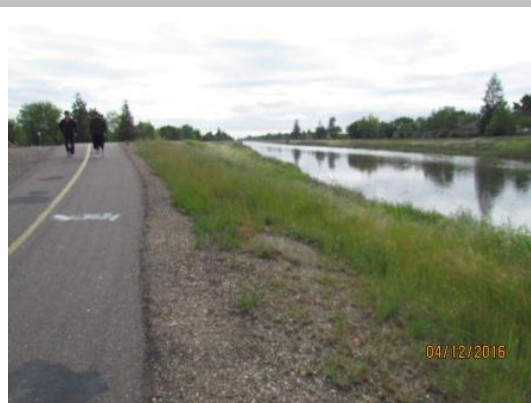
Photo 1 of 1 : SP_2016_NA0017_151_81_20160418_00148.jpg

LM Start	0.33	Rating **	M	Issue No.	81
LM End	4.28	Issue Type +	Ma	Location *	WS
Category	Earthen Levee			GPS Latitude/Longitude	
				Start	End
Item	Vegetation			38.043523 °	38.044609 °
				-121.367624 °	-121.295731 °
DWR ID	DWR_NA0017_07_s_2016_81				
Comment Code					
V2 : Remove the wild growth other than native grasses from the levee slopes.					
Inspector Comment

View of the vegetation on the waterside slope of the levee looking upstream.

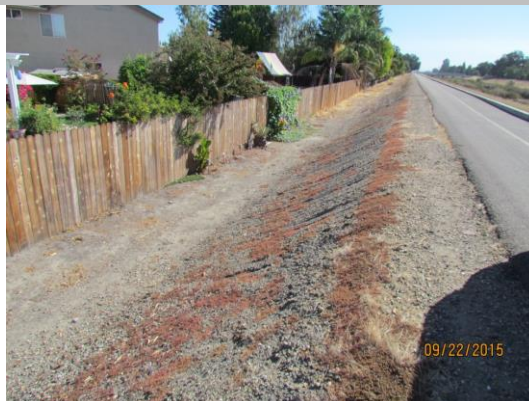
Photo 1 of 2 : SP_2016_NA0017_151_35_20160219_00010.jpg

LM Start	2.01	Rating **	M	Issue No.	35
LM End	2.01	Issue Type +	Ma	Location *	LS
Category	Earthen Levee			GPS Latitude/Longitude	
				Start	End
Item	Erosion / Bank Caving			38.043243 °	38.043243 °
				-121.336780 °	-121.336780 °
DWR ID	DWR_NA0017_07_s _ 2015_35				
Comment Code					
E2 : Schedule repair of erosion site prior to the next inspection.					
Inspector Comment					
Runoff

Updated picture of the erosion on the landside of the levee during fall 2015 inspection.

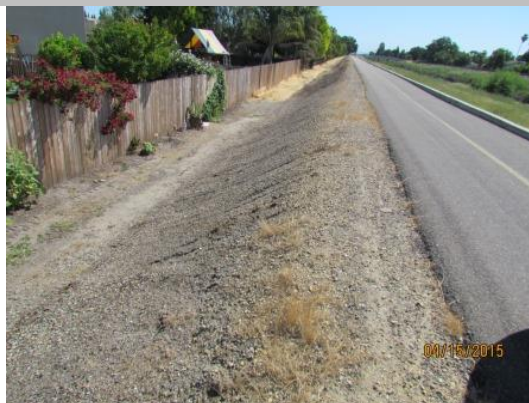
Photo 2 of 2 : SP_2016_NA0017_151_35_20160219_00011.jpg

LM Start	2.01	Rating **	M	Issue No.	35 (cont)
LM End	2.01	Issue Type +	Ma	Location *	LS

Erosion caused by runoff on the landside of the levee looking upstream.

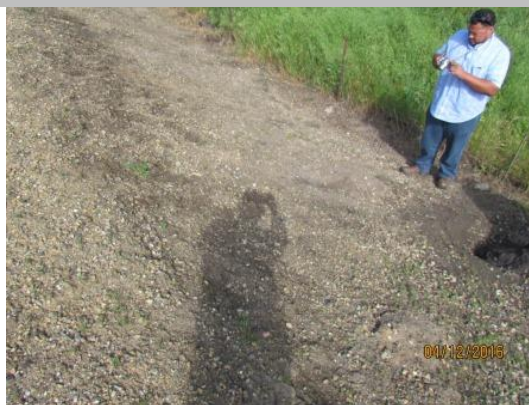
Photo 1 of 1 : SP_2016_NA0017_151_87_20160418_00152.jpg

LM Start	2.72	Rating **	M	Issue No.	87
LM End	2.72	Issue Type +	Ma	Location *	LS
Category	Earthen Levee			GPS Latitude/Longitude	
				Start	End
Item	Animal Control			38.043166 °	38.043166 °
				-121.323879 °	-121.323879 °
DWR ID	DWR_NA0017_07_s_2016_87				
Comment Code					
A3 : No rodents visible, but rodent burrows visible; need to backfill and compact or grout burrows.					
Inspector Comment

View of a rodent hole on the landside of the levee looking downstream.

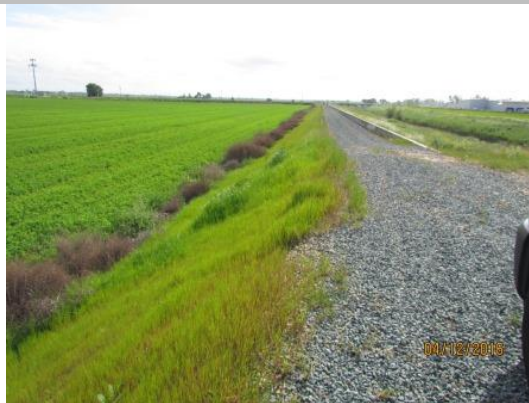
Photo 1 of 1 : SP_2016_NA0017_151_89_20160418_00153.jpg

LM Start	2.84	Rating **	M	Issue No.	89
LM End	4.28	Issue Type +	Ma	Location *	LS
Category	Earthen Levee			GPS Latitude/Longitude	
				Start	End
Item	Vegetation			38.043166 °	38.044609 °
				-121.321620 °	-121.295731 °
DWR ID	DWR_NA0017_07_s_2016_89				
Comment Code					
V1 : Control annual grass and weeds on the levee slopes and easements.					
Inspector Comment

View of the vegetation on the landside of the levee.

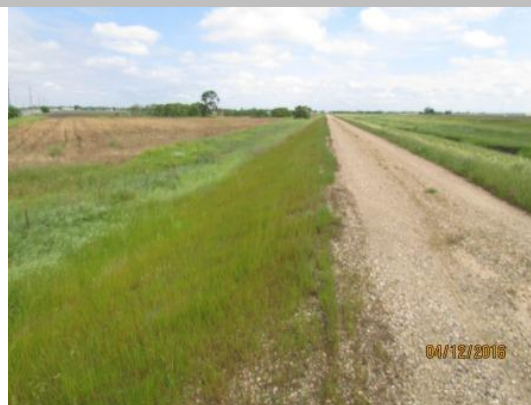
Photo 1 of 1 : SP_2016_NA0017_151_90_20160418_00154.jpg

LM Start	4.34	Rating **	M	Issue No.	90
LM End	6.81	Issue Type +	Ma	Location *	LS
Category	Earthen Levee			GPS Latitude/Longitude	
				Start	End
Item	Vegetation			38.045024 °	38.061650 °
				-121.294994 °	-121.259163 °
DWR ID	DWR_NA0017_07_s_2016_90				
Comment Code					
V1 : Control annual grass and weeds on the levee slopes and easements.					
Inspector Comment

View of vegetation on the landside of the levee.

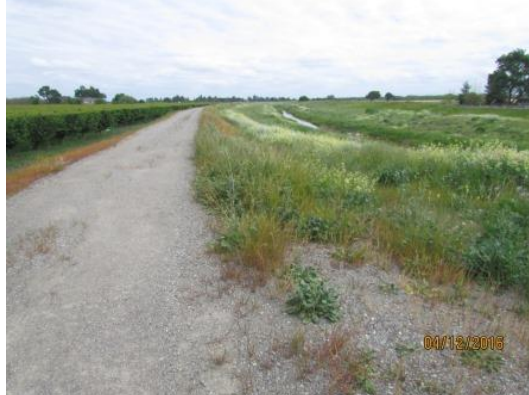
Photo 1 of 1 : SP_2016_NA0017_151_92_20160418_00156.jpg

LM Start	6.82	Rating **	M	Issue No.	92
LM End	10.38	Issue Type +	Ma	Location *	WS
Category	Earthen Levee			GPS Latitude/Longitude	
				Start	End
Item	Vegetation			38.061758 °	38.079592 °
				-121.258989 °	-121.201661 °
DWR ID	DWR_NA0017_07_s _ 2016_92				
Comment Code					
V1 : Control annual grass and weeds on the levee slopes and easements.					
Inspector Comment

View of vegetation on the waterside of the levee looking upstream.

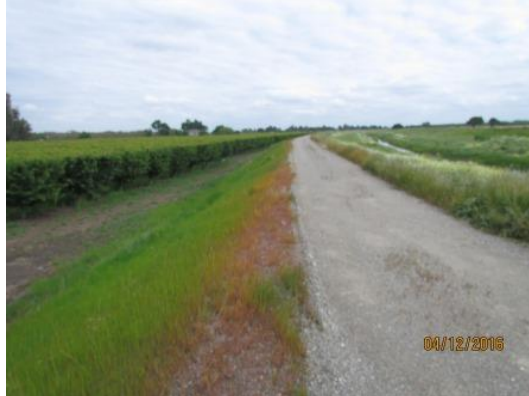
Photo 1 of 1 : SP_2016_NA0017_151_93_20160418_00157.jpg

LM Start	6.82	Rating **	M	Issue No.	93
LM End	8.22	Issue Type +	Ma	Location *	LS
Category	Earthen Levee			GPS Latitude/Longitude	
				Start	End
Item	Vegetation			38.061758 °	38.067509 °
				-121.258988 °	-121.235621 °
DWR ID	DWR_NA0017_07_s _ 2016_93				
Comment Code					
V1 : Control annual grass and weeds on the levee slopes and easements.					
Inspector Comment

View of vegetation on the landside of the levee.

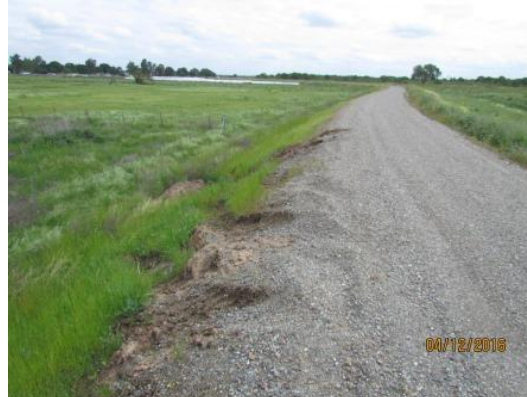
Photo 1 of 1 : SP_2016_NA0017_151_94_20160418_00158.jpg

LM Start	7.23	Rating **	M	Issue No.	94
LM End	7.23	Issue Type +	Ma	Location *	LS
Category	Earthen Levee			GPS Latitude/Longitude	
				Start	End
Item	Slope Stability			38.065001 °	38.065001 °
				-121.252757 °	-121.252757 °
DWR ID	DWR_NA0017_07_s_2016_94				
Comment Code					
S3 : Repair the levee slope damaged by vehicle traffic and prevent access where possible.					
Inspector Comment

View of slope instability on the landside shoulder of the levee looking upstream.

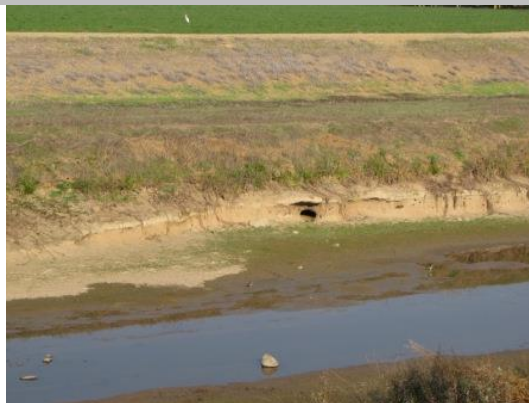
Photo 1 of 1 : SP_2016_NA0017_151_80_20160219_00037.jpg

LM Start	9.65	Rating **	U	Issue No.	80
LM End	9.65	Issue Type +	Ma	Location *	WS
Category	Earthen Levee			GPS Latitude/Longitude	
				Start	End
Item	Animal Control			38.070458 °	38.070458 °
				-121.218596 °	-121.218596 °
DWR ID	DWR_NA0017_07_s _ 2012_80				
Comment Code					
A3 : No rodents visible, but rodent burrows visible; need to backfill and compact or grout burrows.					
Inspector Comment					
Beaver den in the waterward berm visible from the opposite bank.

View of a large hole and several smaller holes from across the channel.

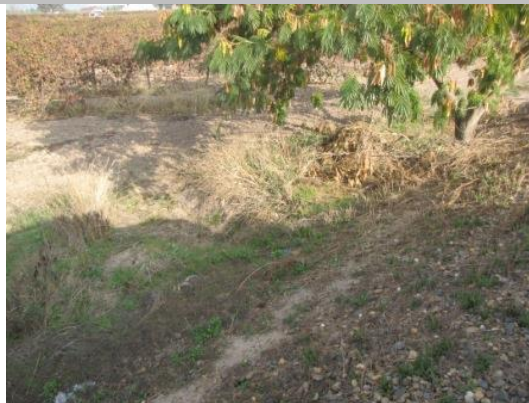
Photo 1 of 1 : SP_2016_NA0017_151_72_20160219_00034.jpg

LM Start	13.03	Rating **	M	Issue No.	72
LM End	13.03	Issue Type +	Ma	Location *	LS
Category	Earthen Levee			GPS Latitude/Longitude	
				Start	End
Item	Slope Stability			38.105846 °	38.105846 °
				-121.176552 °	-121.176552 °
DWR ID	DWR_NA0017_07_s _ 2012_72				
Comment Code					
S1 : Repair slope instability.					
Inspector Comment					
Shallow pit at the landward toe with nearby prunings.

View of a pit along the landward levee toe looking upstream.

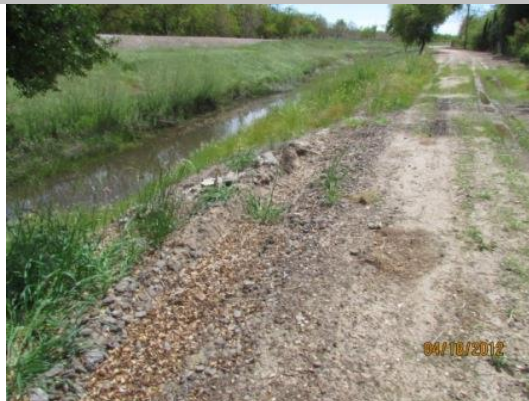
Photo 1 of 1 : SP_2016_NA0017_151_60_20160219_00030.jpg

LM Start	14.35	Rating **	M	Issue No.	60
LM End	14.35	Issue Type +	Ma	Location *	CR
Category	Earthen Levee			GPS Latitude/Longitude	
				Start	End
Item	Crown Surface / Depressions / Rutting			38.123286 °	38.123286 °
				-121.169609 °	-121.169609 °
DWR ID	DWR_NA0017_07_s _ 2012_60				
Comment Code					
C2 : Repair depressions or ruts in the crown or slope.					
Inspector Comment

Crown depression was found on the waterside shoulder of the levee looking downstream.

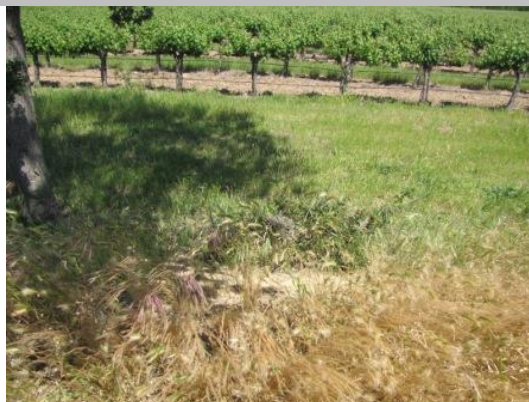
Photo 1 of 1 : SP_2016_NA0017_151_53_20160219_00027.jpg

LM Start	15.04	Rating **	N	Issue No.	53
LM End	15.16	Issue Type +	Ma	Location *	LS
Category	Earthen Levee			GPS Latitude/Longitude	
				Start	End
Item	Trim / Thin Trees			38.129236 °	38.130205 °
				-121.160163 °	-121.158466 °
DWR ID	DWR_NA0017_07_s _ 2012_53				
Comment Code					
T5 : Tree stumps.					
Inspector Comment

View of a stump in the landward slope.

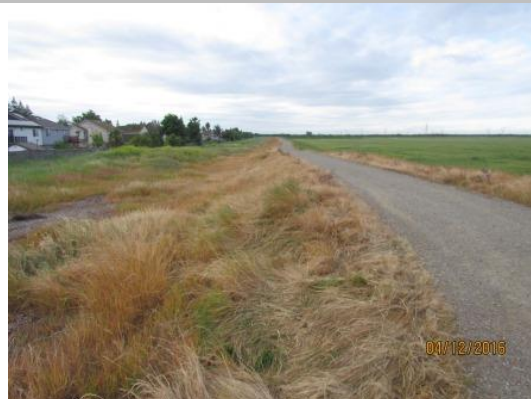
Photo 1 of 1 : SP_2016_NA0017_152_127_20160418_00203.jpg

LM Start	0.75	Rating **	M	Issue No.	127
LM End	0.75	Issue Type +	Ma	Location *	LS
Category	Earthen Levee			GPS Latitude/Longitude	
				Start	End
Item	Vegetation			38.042747 °	38.042747 °
				-121.370753 °	-121.370753 °
DWR ID	DWR_NA0017_08_s _ 2016_127				
Comment Code					
V1 : Control annual grass and weeds on the levee slopes and easements.					
Inspector Comment					
This portion of the levee is not maintained by the LMA, and this portion of the alignment runs perpendicular to Bear Creek. This unit is Bear Creek unit 8a.

View of the vegetation on the landside slope of the levee.

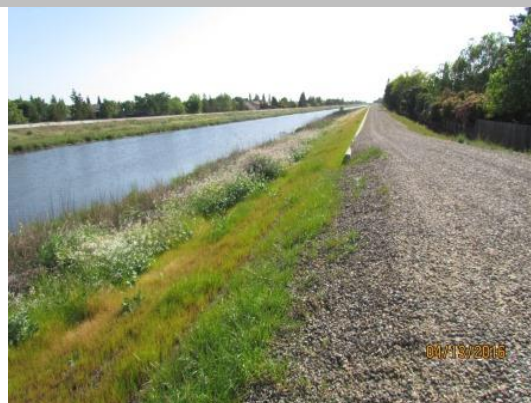
Photo 1 of 1 : SP_2016_NA0017_152_131_20160418_00205.jpg

LM Start	0.94	Rating **	M	Issue No.	131
LM End	1.95	Issue Type +	Ma	Location *	WS
Category	Earthen Levee			GPS Latitude/Longitude	
				Start	End
Item	Vegetation			38.043023 °	38.042810 °
				-121.366953 °	-121.348467 °
DWR ID	DWR_NA0017_08_s _ 2016_131				
Comment Code					
V1 : Control annual grass and weeds on the levee slopes and easements.					
Inspector Comment

View of the vegetation on the waterside of the levee looking upstream.

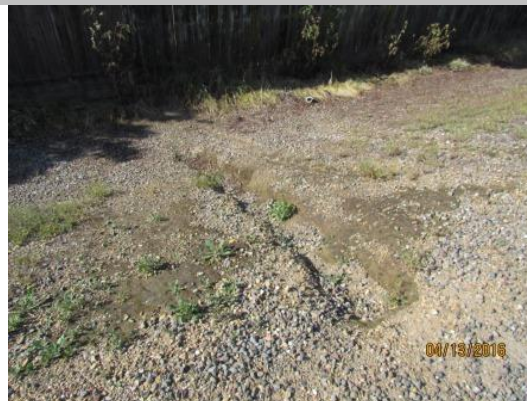
Photo 1 of 1 : SP_2016_NA0017_152_130_20160418_00204.jpg

LM Start	1.30	Rating **	M	Issue No.	130
LM End	1.30	Issue Type +	Ma	Location *	LS
Category	Earthen Levee			GPS Latitude/Longitude	
				Start	End
Item	Encroachments			38.042905 °	38.042905 °
				-121.360449 °	-121.360449 °
DWR ID	DWR_NA0017_08_s_2016_130				
Comment Code					
ST : Stairway					
Inspector Comment

View of the steps dug into the landside slope of the levee.

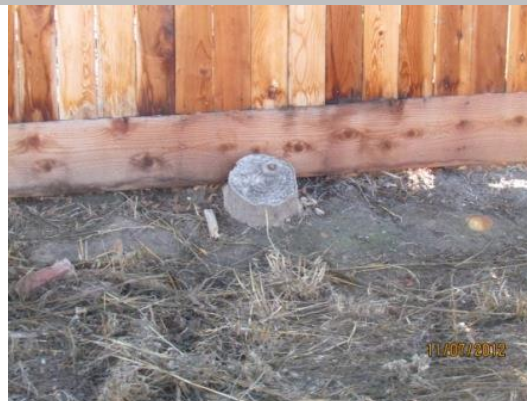
Photo 1 of 1 : SP_2016_NA0017_152_18_20160219_00005.jpg

LM Start	1.82	Rating **	N	Issue No.	18	
LM End	1.82	Issue Type +	Ma	Location *	LS	
Category	Earthen Levee			GPS Latitude/Longitude		
				Start		End
Item	Trim / Thin Trees			38.042751 °		38.042751 °
				-121.353062 °		-121.353062 °
DWR ID	DWR_NA0017_08_f_2012_18					
Comment Code						
T5 : Tree stumps.						
Inspector Comment

View of a tree stump that was found on the landside toe of the levee.
The picture was taken from the crown looking towards the toe.

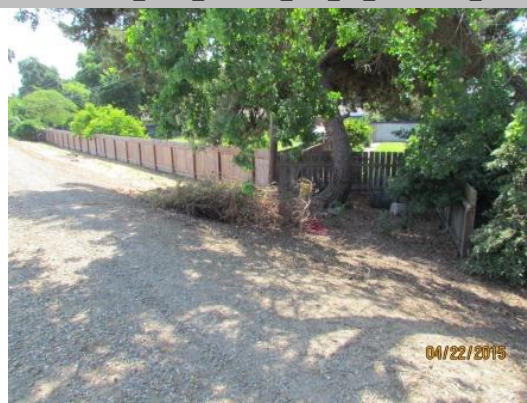
Photo 1 of 1 : SP_2016_NA0017_152_92_20160219_00034.jpg

LM Start	2.04	Rating **	M	Issue No.	92
LM End	2.04	Issue Type +	Ma	Location *	LS
Category	Earthen Levee			GPS Latitude/Longitude	
				Start	End
Item	Encroachments			38.042803 °	38.042803 °
				-121.346755 °	-121.346755 °
DWR ID	DWR_NA0017_08_s_2015_92				
Comment Code					
PR : Prunings					
Inspector Comment

Prunings were found on the landside of the levee looking upstream.

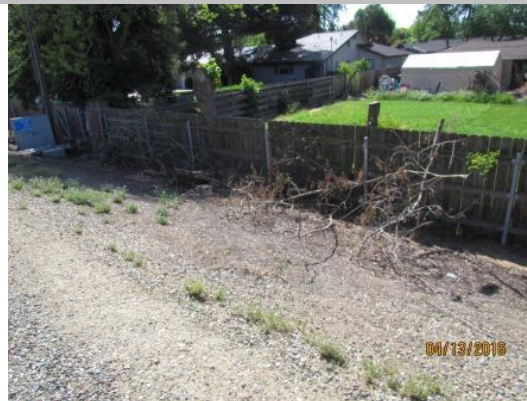
Photo 1 of 1 : SP_2016_NA0017_152_134_20160418_00206.jpg

LM Start	2.14	Rating **	M	Issue No.	134
LM End	2.14	Issue Type +	Ma	Location *	LS
Category	Earthen Levee			GPS Latitude/Longitude	
				Start	End
Item	Encroachments			38.042774 °	38.042774 °
				-121.344979 °	-121.344979 °
DWR ID	DWR_NA0017_08_s_2016_134				
Comment Code					
PR : Prunings					
Inspector Comment

View of prunings at the landside toe of the levee.

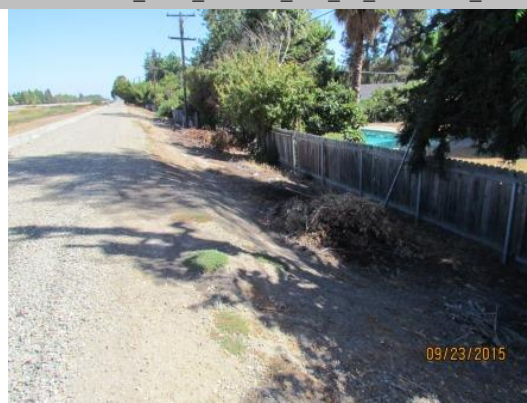
Photo 1 of 1 : SP_2016_NA0017_152_93_20160219_00035.jpg

LM Start	2.16	Rating **	M	Issue No.	93
LM End	2.16	Issue Type +	Ma	Location *	LS
Category	Earthen Levee			GPS Latitude/Longitude	
				Start	End
Item	Encroachments			38.042785 °	38.042785 °
				-121.344686 °	-121.344686 °
DWR ID	DWR_NA0017_08_s_2015_93				
Comment Code					
PR : Prunings					
Inspector Comment

Prunings were found on the landside of the levee looking upstream.

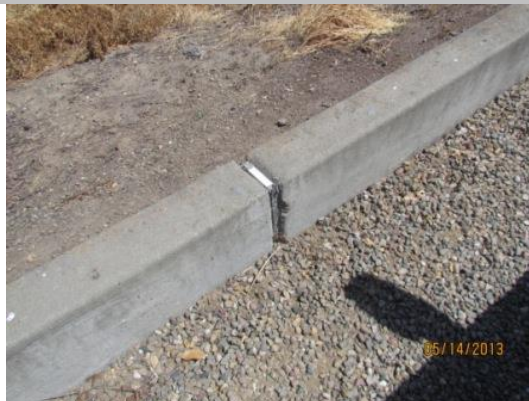
Photo 1 of 1 : SP_2016_NA0017_152_29_20160219_00009.jpg

LM Start	2.24	Rating **	M	Issue No.	29
LM End	2.24	Issue Type +	Ma	Location *	WS
Category	Concrete Floodwalls			GPS Latitude/Longitude	
				Start	End
Item	Monolith Joints			38.042777 °	38.042777 °
				-121.343150 °	-121.343150 °
DWR ID	DWR_NA0017_08_s _ 2013_29				
Comment Code					
Inspector Comment

The monolith joint material is deteriorating at this location of the flood wall. The picture was taken from the crown looking upstream.

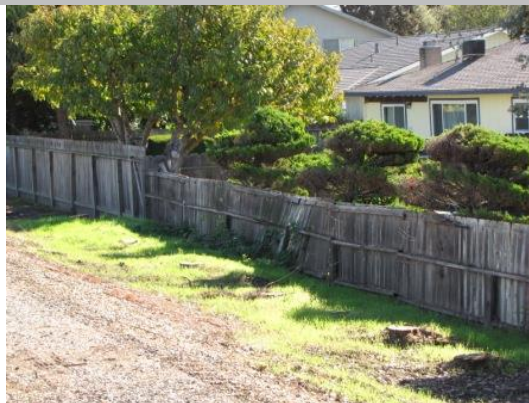
Photo 1 of 1 : SP_2016_NA0017_152_12_20160219_00003.jpg

LM Start	2.50	Rating **	N	Issue No.	12
LM End	2.50	Issue Type +	Ma	Location *	LS
Category	Earthen Levee			GPS Latitude/Longitude	
				Start	End
Item	Trim / Thin Trees			38.042749 °	38.042749 °
				-121.338402 °	-121.338402 °
DWR ID	DWR_NA0017_08_s_2012_12				
Comment Code					
T5 : Tree stumps.					
Inspector Comment

View of stumps along the landward toe looking upstream.

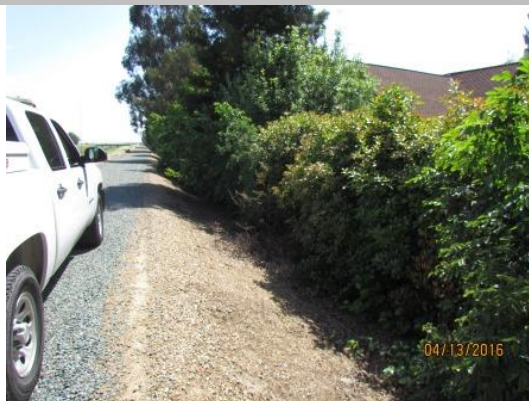
Photo 1 of 1 : SP_2016_NA0017_152_138_20160418_00207.jpg

LM Start	3.11	Rating **	M	Issue No.	138
LM End	3.14	Issue Type +	Ma	Location *	LS
Category	Earthen Levee			GPS Latitude/Longitude	
				Start	End
Item	Trim / Thin Trees			38.042654 °	38.042646 °
				-121.327229 °	-121.326561 °
DWR ID	DWR_NA0017_08_s_2016_138				
Comment Code					
T3 : Trim and thin trees to allow visibility of the ground and room to flood fight.					
Inspector Comment

View of tree limbs that were blocking the visibility and accessibility of the landside slope of the levee.

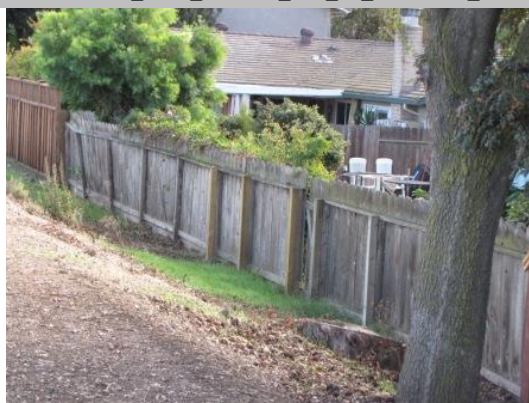
Photo 1 of 1 : SP_2016_NA0017_152_13_20160219_00004.jpg

LM Start	3.19	Rating **	N	Issue No.	13
LM End	3.19	Issue Type +	Ma	Location *	LS
Category	Earthen Levee			GPS Latitude/Longitude	
				Start	End
Item	Trim / Thin Trees			38.042676 °	38.042676 °
				-121.325694 °	-121.325694 °
DWR ID	DWR_NA0017_08_s_2012_13				
Comment Code					
T5 : Tree stumps.					
Inspector Comment

View of a stump on the landward slope looking upstream.

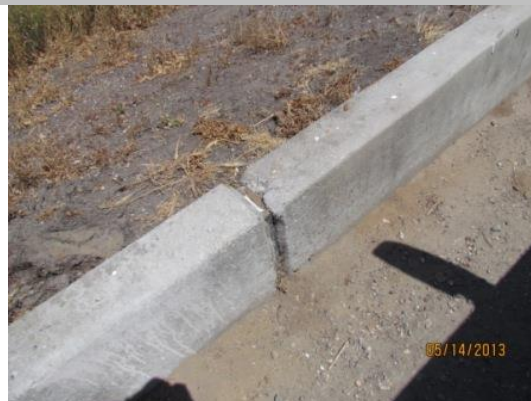
Photo 1 of 1 : SP_2016_NA0017_152_37_20160219_00010.jpg

LM Start	3.24	Rating **	M	Issue No.	37
LM End	3.24	Issue Type +	Ma	Location *	WS
Category	Concrete Floodwalls			GPS Latitude/Longitude	
				Start	End
Item	Monolith Joints			38.042652 °	38.042652 °
				-121.326883 °	-121.326883 °
DWR ID	DWR_NA0017_08_s_2013_37				
Comment Code					
Inspector Comment

The monolith joint material is deteriorating at this location of the flood wall. The picture was taken from the crown looking upstream.

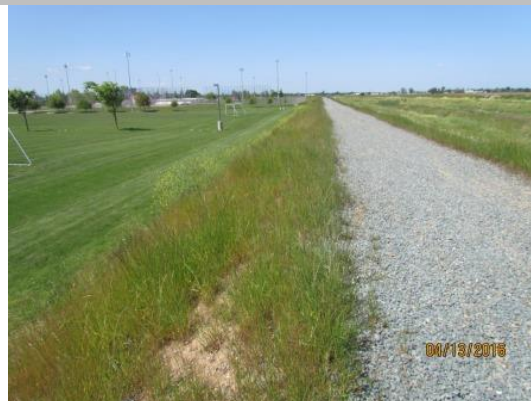
Photo 1 of 1 : SP_2016_NA0017_152_139_20160418_00208.jpg

LM Start	4.48	Rating **	M	Issue No.	139
LM End	4.85	Issue Type +	Ma	Location *	LS
Category	Earthen Levee			GPS Latitude/Longitude	
				Start	End
Item	Vegetation			38.042456 °	38.043954 °
				-121.302124 °	-121.295723 °
DWR ID	DWR_NA0017_08_s _ 2016_139				
Comment Code					
V1 : Control annual grass and weeds on the levee slopes and easements.					
Inspector Comment

View of vegetation on the landside of the levee.

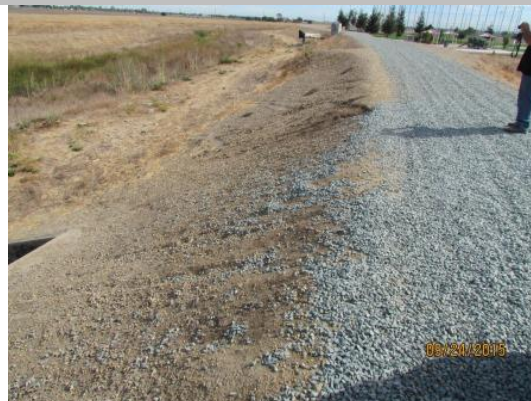
Photo 2 of 2 : SP_2016_NA0017_152_27_20160219_00007.jpg

LM Start	4.56	Rating **	M	Issue No.	27 (cont)	
LM End	4.56	Issue Type +	Ma	Location *	WS	
Category	Earthen Levee			GPS Latitude/Longitude		
				Start		End
Item	Erosion / Bank Caving			38.042797 °		38.042797 °
				-121.300782 °		-121.300782 °
DWR ID	DWR_NA0017_08_s_2014_27					
Comment Code						
E2 : Schedule repair of erosion site prior to the next inspection.						
Inspector Comment						
Ruts on the waterside slope of the levee.

Erosion caused by runoffs on the waterside slope of the levee looking upstream.

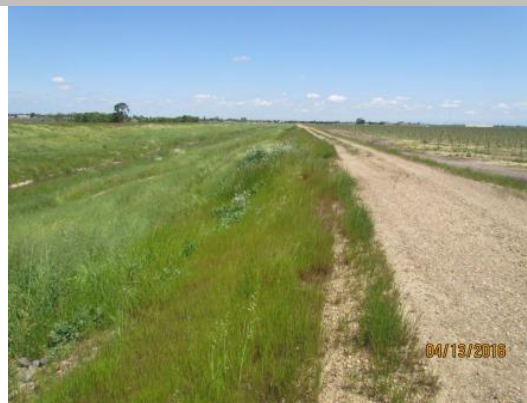
Photo 1 of 1 : SP_2016_NA0017_152_144_20160418_00214.jpg

LM Start	4.91	Rating **	M	Issue No.	144
LM End	6.68	Issue Type +	Ma	Location *	LS
Category	Earthen Levee			GPS Latitude/Longitude	
				Start	End
Item	Vegetation			38.044310 °	38.053896 °
				-121.294781 °	-121.266972 °
DWR ID	DWR_NA0017_08_s_2016_144				
Comment Code					
V1 : Control annual grass and weeds on the levee slopes and easements.					
Inspector Comment

View of the vegetation on the landside of the levee.

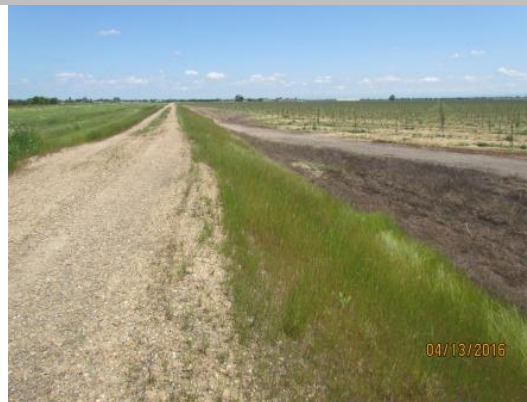
Photo 1 of 1 : SP_2016_NA0017_152_143_20160418_00211.jpg

LM Start	4.91	Rating **	M	Issue No.	143
LM End	7.07	Issue Type +	Ma	Location *	WS
Category	Earthen Levee			GPS Latitude/Longitude	
				Start	End
Item	Vegetation			38.044310 °	38.057072 °
				-121.294781 °	-121.261584 °
DWR ID	DWR_NA0017_08_s_2016_143				
Comment Code					
V1 : Control annual grass and weeds on the levee slopes and easements.					
Inspector Comment

View of the vegetation on the waterside of the levee.

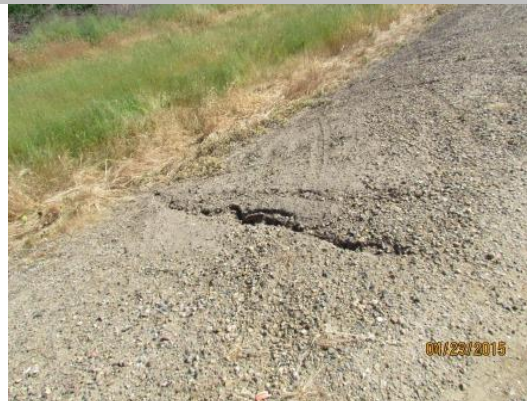
Photo 1 of 1 : SP_2016_NA0017_152_6_20160219_00002.jpg

LM Start	6.16	Rating **	M	Issue No.	6
LM End	6.16	Issue Type +	Ma	Location *	WS
Category	Earthen Levee			GPS Latitude/Longitude	
				Start	End
Item	Slope Stability			38.052204 °	38.052204 °
				-121.276014 °	-121.276014 °
DWR ID	DWR_NA0017_08_s_2015_6				
Comment Code					
S1 : Repair slope instability.					
Inspector Comment					
Runoff

View of a slope instability due to runoff on the waterside of the levee looking upstream.

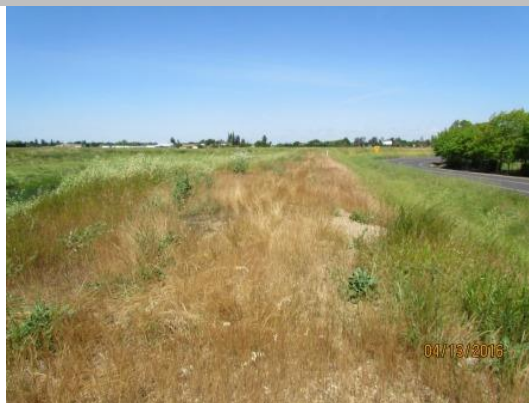
Photo 1 of 1 : SP_2016_NA0017_152_146_20160418_00216.jpg

LM Start	7.11	Rating **	M	Issue No.	146
LM End	7.36	Issue Type +	Ma	Location *	CR
Category	Earthen Levee			GPS Latitude/Longitude	
				Start	End
Item	Vegetation			38.057677 °	38.060597 °
				-121.261463 °	-121.259142 °
DWR ID	DWR_NA0017_08_s_2016_146				
Comment Code					
V1 : Control annual grass and weeds on the levee slopes and easements.					
Inspector Comment

View of vegetation on the crown of the levee.

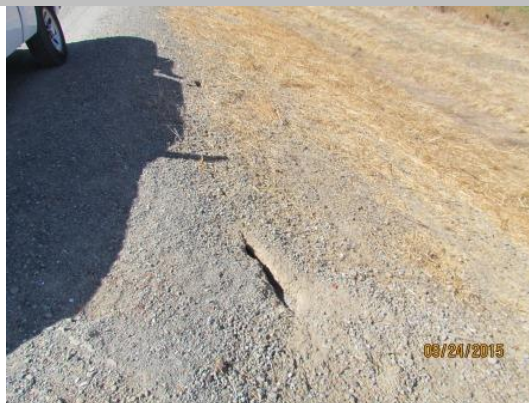
Photo 1 of 1 : SP_2016_NA0017_152_72_20160219_00024.jpg

LM Start	7.86	Rating **	M	Issue No.	72
LM End	7.86	Issue Type +	Ma	Location *	WS
Category	Earthen Levee			GPS Latitude/Longitude	
				Start	End
Item	Animal Control			38.064436 °	38.064436 °
				-121.251746 °	-121.251746 °
DWR ID	DWR_NA0017_08_f_2015_72				
Comment Code					
A3 : No rodents visible, but rodent burrows visible; need to backfill and compact or grout burrows.					
Inspector Comment

An animal hole was found on the waterside shoulder of the levee looking downstream.

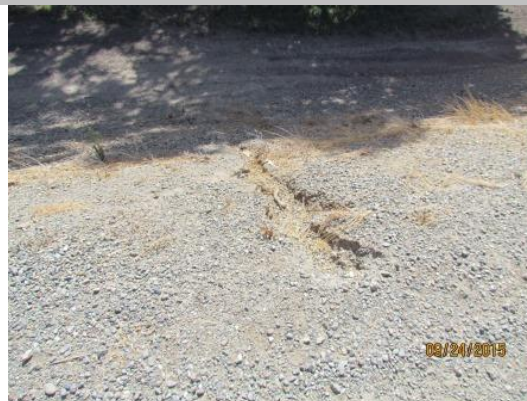
Photo 1 of 1 : SP_2016_NA0017_152_73_20160219_00025.jpg

LM Start	8.83	Rating **	M	Issue No.	73
LM End	8.83	Issue Type +	Ma	Location *	LS
Category	Earthen Levee			GPS Latitude/Longitude	
				Start	End
Item	Erosion / Bank Caving			38.067130 °	38.067130 °
				-121.234875 °	-121.234875 °
DWR ID	DWR_NA0017_08_f_2015_73				
Comment Code					
E2 : Schedule repair of erosion site prior to the next inspection.					
Inspector Comment					
Surface runoff.

Erosion due surface runoff was found on the landside of the levee looking downstream.

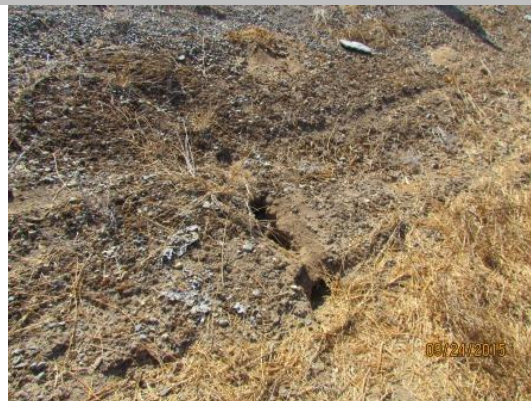
Photo 1 of 1 : SP_2016_NA0017_152_75_20160219_00026.jpg

LM Start	9.42	Rating **	M	Issue No.	75
LM End	9.42	Issue Type +	Ma	Location *	WS
Category	Earthen Levee			GPS Latitude/Longitude	
				Start	End
Item	Animal Control			38.069797 °	38.069797 °
				-121.224693 °	-121.224693 °
DWR ID	DWR_NA0017_08_f_2015_75				
Comment Code					
A3 : No rodents visible, but rodent burrows visible; need to backfill and compact or grout burrows.					
Inspector Comment

Rodent holes were found on the waterside of the levee looking downstream.

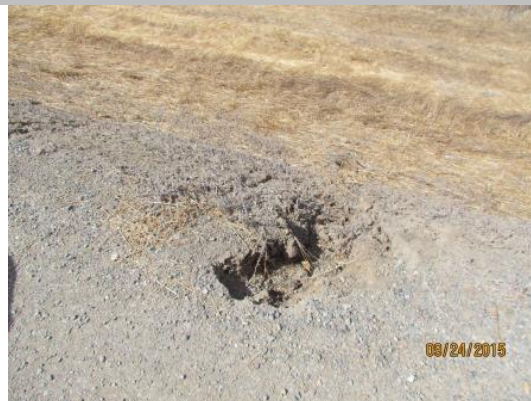
Photo 1 of 1 : SP_2016_NA0017_152_80_20160219_00030.jpg

LM Start	11.73	Rating **	M	Issue No.	80
LM End	11.73	Issue Type +	Ma	Location *	WS
Category	Earthen Levee			GPS Latitude/Longitude	
				Start	End
Item	Slope Stability			38.086219 °	38.086219 °
				-121.190030 °	-121.190030 °
DWR ID	DWR_NA0017_08_f_2015_80				
Comment Code					
S1 : Repair slope instability.					
Inspector Comment

Slope instability was found on the waterside of the levee looking downstream.

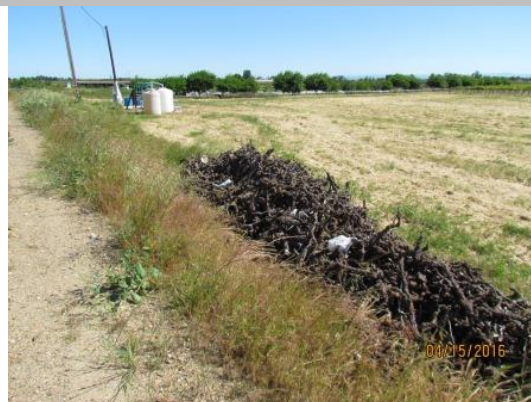
Photo 1 of 1 : SP_2016_NA0017_152_133_20160418_00217.jpg

LM Start	12.84	Rating **	M	Issue No.	133
LM End	12.84	Issue Type +	Ma	Location *	LS
Category	Earthen Levee			GPS Latitude/Longitude	
				Start	End
Item	Encroachments			38.096581 °	38.096581 °
				-121.175898 °	-121.175898 °
DWR ID	DWR_NA0017_08_s_2015_133				
Comment Code					
PR : Prunings					
Inspector Comment

View of prunings on the landside toe of the levee.

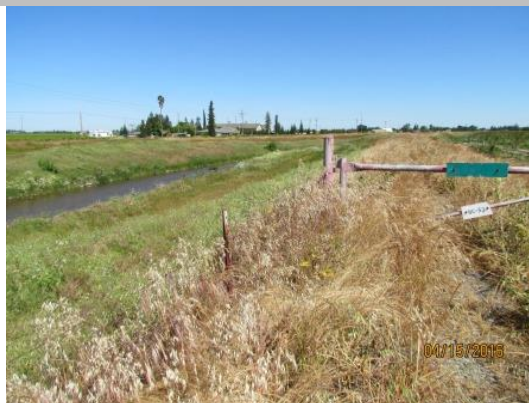
Photo 1 of 1 : SP_2016_NA0017_152_153_20160418_00218.jpg

LM Start	13.23	Rating **	M	Issue No.	153
LM End	16.00	Issue Type +	Ma	Location *	WS
Category	Earthen Levee			GPS Latitude/Longitude	
				Start	End
Item	Vegetation			38.101790 °	38.131890 °
				-121.177160 °	-121.150870 °
DWR ID	DWR_NA0017_08_s _ 2016_153				
Comment Code					
V1 : Control annual grass and weeds on the levee slopes and easements.					
Inspector Comment

View of the vegetation on the waterside slope of the levee.

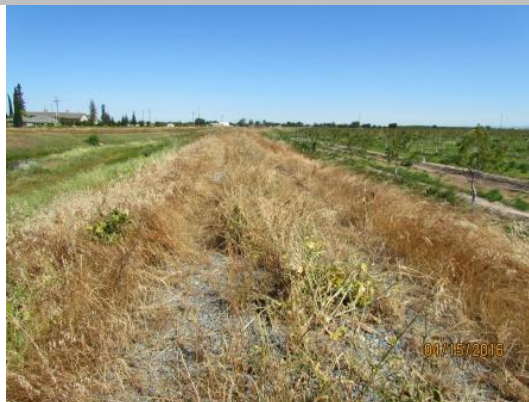
Photo 1 of 1 : SP_2016_NA0017_152_154_20160418_00219.jpg

LM Start	13.23	Rating **	M	Issue No.	154
LM End	16.00	Issue Type +	Ma	Location *	CR
Category	Earthen Levee			GPS Latitude/Longitude	
				Start	End
Item	Vegetation			38.101790 °	38.131890 °
				-121.177160 °	-121.150869 °
DWR ID	DWR_NA0017_08_s _ 2016_154				
Comment Code					
V1 : Control annual grass and weeds on the levee slopes and easements.					
Inspector Comment

View of the vegetation on the crown of the levee.

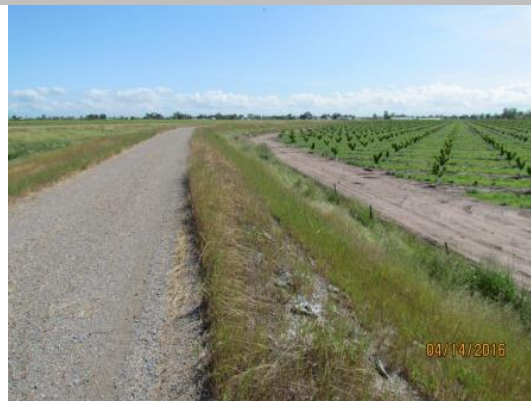
Photo 1 of 1 : SP_2016_NA0017_153_5_20160418_00012.jpg

LM Start	0.06	Rating **	M	Issue No.	5
LM End	1.43	Issue Type +	Ma	Location *	WS
Category	Earthen Levee			GPS Latitude/Longitude	
				Start	End
Item	Vegetation			38.093568 °	38.094069 °
				-121.175671 °	-121.151129 °
DWR ID	DWR_NA0017_09_s_2016_5				
Comment Code					
V1 : Control annual grass and weeds on the levee slopes and easements.					
Inspector Comment

View of the vegetation on the waterside of the levee.

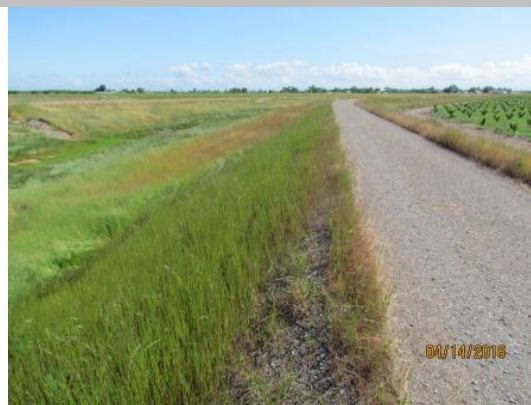
Photo 1 of 1 : SP_2016_NA0017_153_6_20160418_00011.jpg

LM Start	0.06	Rating **	M	Issue No.	6
LM End	1.43	Issue Type +	Ma	Location *	LS
Category	Earthen Levee			GPS Latitude/Longitude	
				Start	End
Item	Vegetation			38.093568 °	38.094069 °
				-121.175671 °	-121.151129 °
DWR ID	DWR_NA0017_09_s_2016_6				
Comment Code					
V1 : Control annual grass and weeds on the levee slopes and easements.					
Inspector Comment

View of the vegetation on the landside of the levee.

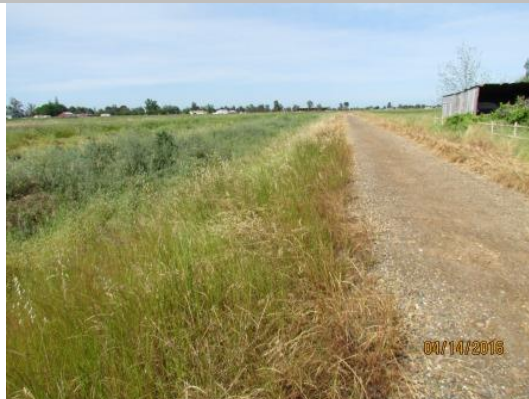
Photo 1 of 1 : SP_2016_NA0017_154_4_20160418_00009.jpg

LM Start	0.02	Rating **	M	Issue No.	4
LM End	1.31	Issue Type +	Ma	Location *	WS
Category	Earthen Levee			GPS Latitude/Longitude	
				Start	End
Item	Vegetation			38.094140 °	38.095008 °
				-121.175654 °	-121.168368 °
DWR ID	DWR_NA0017_10_s_2016_4				
Comment Code					
V1 : Control annual grass and weeds on the levee slopes and easements.					
Inspector Comment

View of the vegetation on the waterside of the levee.

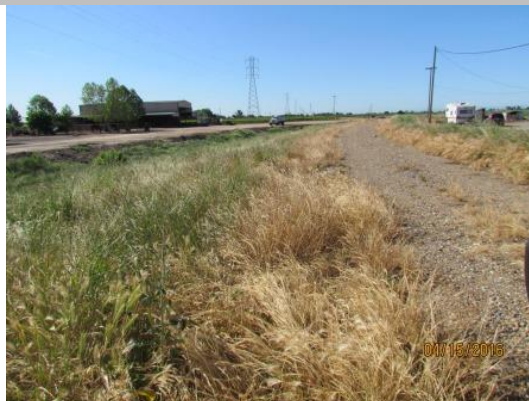
Photo 1 of 1 : SP_2016_NA0017_155_20_20160418_00046.jpg

LM Start	0.03	Rating **	M	Issue No.	20
LM End	3.52	Issue Type +	Ma	Location *	WS
Category	Earthen Levee			GPS Latitude/Longitude	
				Start	End
Item	Vegetation			38.095355 °	38.131641 °
				-121.169471 °	-121.138827 °
DWR ID	DWR_NA0017_11_s _ 2016_20				
Comment Code					
V1 : Control annual grass and weeds on the levee slopes and easements.					
Inspector Comment

View of the vegetation on the waterside of the levee.

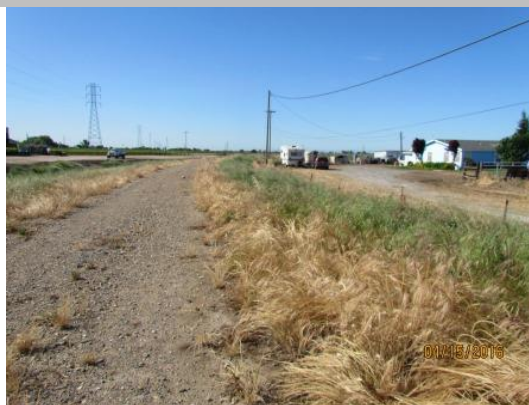
Photo 1 of 1 : SP_2016_NA0017_155_21_20160418_00047.jpg

LM Start	0.03	Rating **	M	Issue No.	21
LM End	3.52	Issue Type +	Ma	Location *	LS
Category	Earthen Levee			GPS Latitude/Longitude	
				Start	End
Item	Vegetation			38.095356 °	38.131640 °
				-121.169471 °	-121.138827 °
DWR ID	DWR_NA0017_11_s _ 2016_21				
Comment Code					
V1 : Control annual grass and weeds on the levee slopes and easements.					
Inspector Comment

View of the vegetation on the landside of the levee.

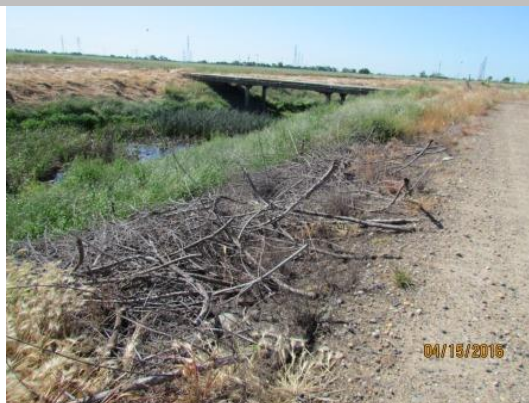
Photo 1 of 1 : SP_2016_NA0017_155_22_20160418_00049.jpg

LM Start	2.90	Rating **	M	Issue No.	22
LM End	2.90	Issue Type +	Ma	Location *	WS
Category	Earthen Levee			GPS Latitude/Longitude	
				Start	End
Item	Encroachments			38.124959 °	38.124959 °
				-121.144223 °	-121.144223 °
DWR ID	DWR_NA0017_11_s _ 2016_22				
Comment Code					
PR : Prunings					
Inspector Comment

Prunings were found on the waterside shoulder of the levee.

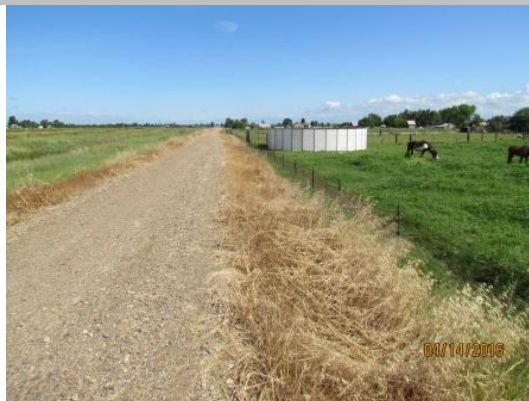
Photo 1 of 1 : SP_2016_NA0017_156_29_20160418_00054.jpg

LM Start	0.03	Rating **	M	Issue No.	29
LM End	1.57	Issue Type +	Ma	Location *	LS
Category	Earthen Levee			GPS Latitude/Longitude	
				Start	End
Item	Vegetation			38.095487 °	38.112677 °
				-121.168775 °	-121.158457 °
DWR ID	DWR_NA0017_12_s _ 2016_29				
Comment Code					
V1 : Control annual grass and weeds on the levee slopes and easements.					
Inspector Comment

View of the vegetation on the landside of the levee.

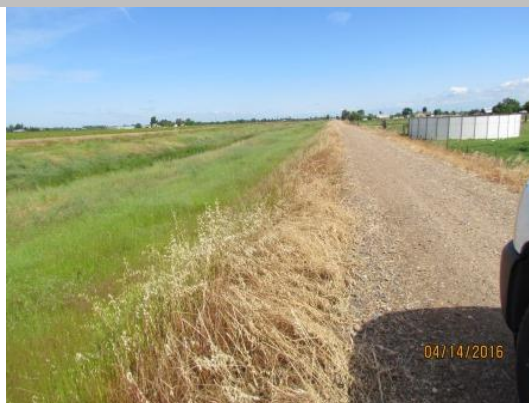
Photo 1 of 1 : SP_2016_NA0017_156_27_20160418_00053.jpg

LM Start	0.03	Rating **	M	Issue No.	27
LM End	3.50	Issue Type +	Ma	Location *	WS
Category	Earthen Levee			GPS Latitude/Longitude	
				Start	End
Item	Vegetation			38.095488 °	38.131584 °
				-121.168775 °	-121.138448 °
DWR ID	DWR_NA0017_12_s _ 2016_27				
Comment Code					
V1 : Control annual grass and weeds on the levee slopes and easements.					
Inspector Comment

View of the vegetation on the waterside of the levee.

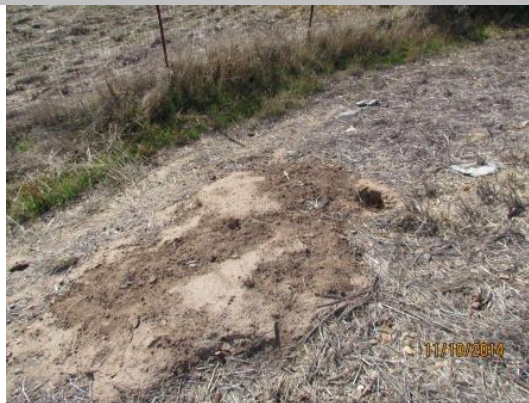
Photo 1 of 2 : SP_2016_NA0017_156_9_20160219_00007.jpg

LM Start	2.22	Rating **	M	Issue No.	9 (cont)
LM End	2.22	Issue Type +	Ma	Location *	LS

Updated picture of the rodent holes on the landside of the levee looking downstream.

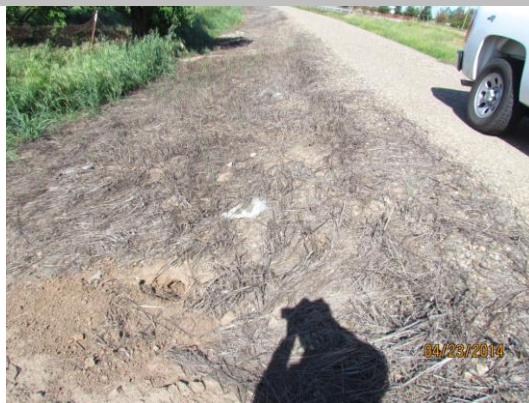
Photo 2 of 2 : SP_2016_NA0017_156_9_20160219_00008.jpg

View of a rodent hole that was found on the landside of the levee looking downstream.

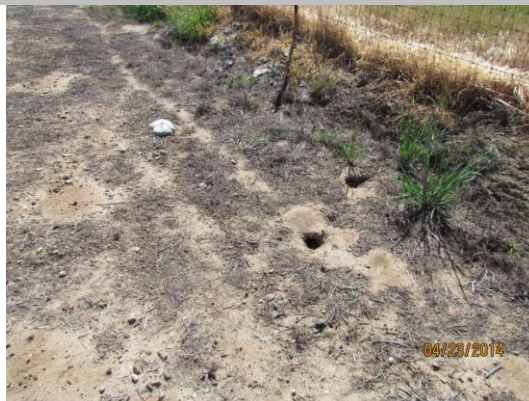
Photo 1 of 1 : SP_2016_NA0017_156_11_20160219_00009.jpg

LM Start	2.25	Rating **	M	Issue No.	11
LM End	2.25	Issue Type +	Ma	Location *	LS
Category	Earthen Levee			GPS Latitude/Longitude	
				Start	End
Item	Animal Control			38.117807 °	38.117807 °
				-121.149233 °	-121.149233 °
DWR ID	DWR_NA0017_12_s_2014_11				
Comment Code					
A3 : No rodents visible, but rodent burrows visible; need to backfill and compact or grout burrows.					
Inspector Comment

View of rodent holes that were found on the landside toe of the levee upstream.

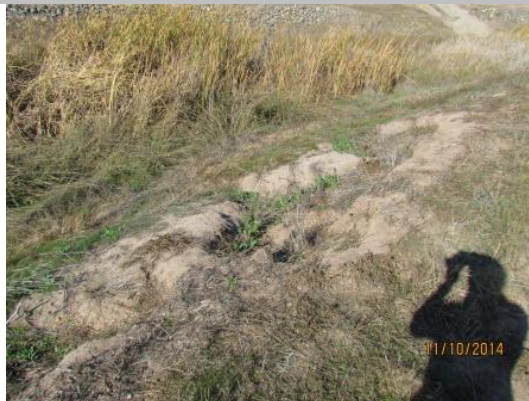
Photo 1 of 1 : SP_2016_NA0017_156_32_20160219_00013.jpg

LM Start	2.97	Rating **	M	Issue No.	32
LM End	2.97	Issue Type +	Ma	Location *	WS
Category	Earthen Levee			GPS Latitude/Longitude	
				Start	End
Item	Slope Stability			38.126304 °	38.126304 °
				-121.143996 °	-121.143996 °
DWR ID	DWR_NA0017_12_f_2014_32				
Comment Code					
S1 : Repair slope instability.					
Inspector Comment

View of a slope instability that was found on the waterside of the levee looking upstream.

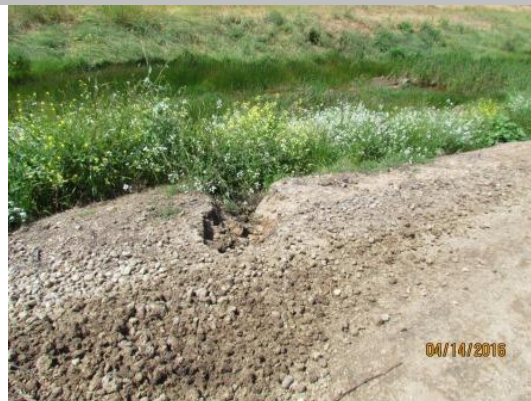
Photo 1 of 2 : SP_2016_NA0017_156_24_20160418_00056.jpg

LM Start	3.46	Rating **	M	Issue No.	24
LM End	3.46	Issue Type +	Ma	Location *	WS
Category	Earthen Levee			GPS Latitude/Longitude	
				Start	End
Item	Erosion / Bank Caving			38.131140 °	38.131140 °
				-121.138541 °	-121.138541 °
DWR ID	DWR_NA0017_12_f_2012_24				
Comment Code					
E2 : Schedule repair of erosion site prior to the next inspection.					
Inspector Comment

Updated picture of the erosion on the waterside of the levee during spring 2016 inspection.

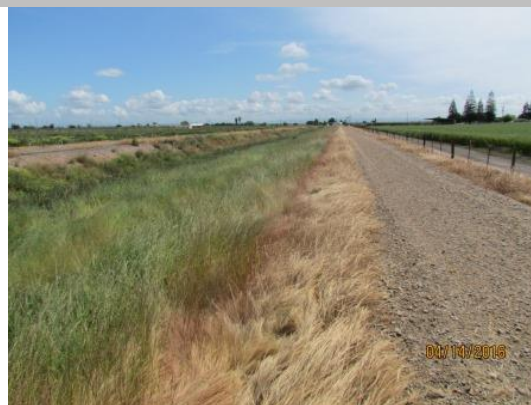
Photo 1 of 1 : SP_2016_NA0017_157_5_20160418_00009.jpg

LM Start	0.18	Rating **	M	Issue No.	5
LM End	1.38	Issue Type +	Ma	Location *	WS
Category	Earthen Levee			GPS Latitude/Longitude	
				Start	End
Item	Vegetation			38.109450 °	38.110836 °
				-121.157268 °	-121.138833 °
DWR ID	DWR_NA0017_13_s_2016_5				
Comment Code					
V1 : Control annual grass and weeds on the levee slopes and easements.					
Inspector Comment

View of the vegetation on the waterside of the levee.

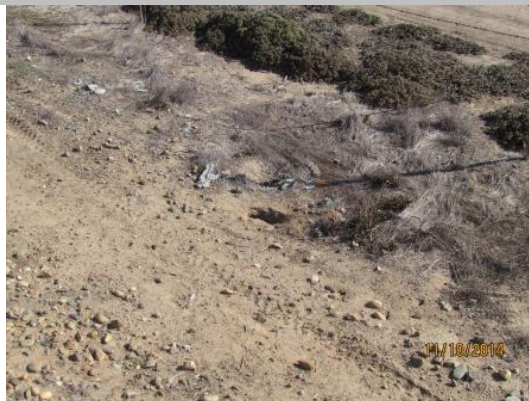
Photo 1 of 1 : SP_2016_NA0017_157_8_20160219_00005.jpg

LM Start	1.02	Rating **	M	Issue No.	8	
LM End	1.02	Issue Type +	Ma	Location *	LS	
Category	Earthen Levee			GPS Latitude/Longitude		
				Start		End
Item	Animal Control			38.110906 °		38.110906 °
				-121.144116 °		-121.144116 °
DWR ID	DWR_NA0017_13_f_2014_8					
Comment Code						
A3 : No rodents visible, but rodent burrows visible; need to backfill and compact or grout burrows.						
Inspector Comment

View of an animal hole that was found on the landside of the levee looking upstream.

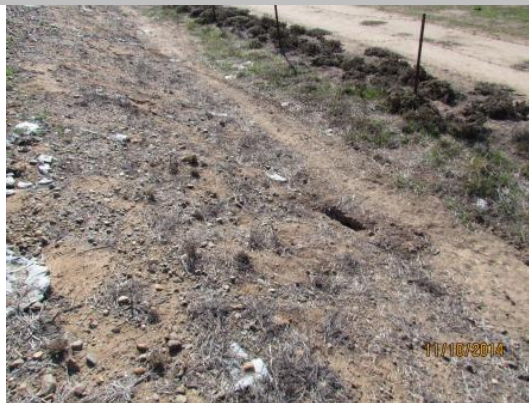
Photo 1 of 1 : SP_2016_NA0017_157_7_20160219_00004.jpg

LM Start	1.21	Rating **	M	Issue No.	7
LM End	1.21	Issue Type +	Ma	Location *	LS
Category	Earthen Levee			GPS Latitude/Longitude	
				Start	End
Item	Animal Control			38.111513 °	38.111513 °
				-121.141216 °	-121.141216 °
DWR ID	DWR_NA0017_13_f_2014_7				
Comment Code					
A3 : No rodents visible, but rodent burrows visible; need to backfill and compact or grout burrows.					
Inspector Comment

View of an animal hole that was found on the landside toe of the levee looking upstream.

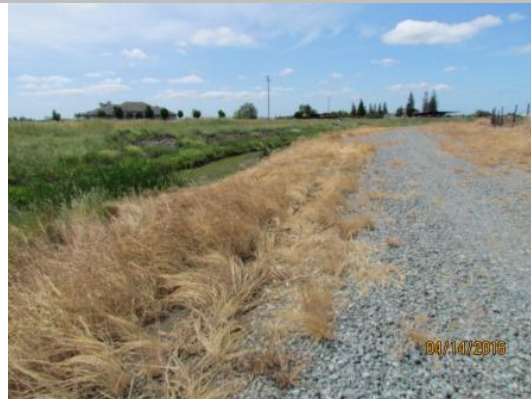
Photo 1 of 1 : SP_2016_NA0017_158_21_20160418_00040.jpg

LM Start	0.04	Rating **	M	Issue No.	21
LM End	0.44	Issue Type +	Ma	Location *	WS
Category	Earthen Levee			GPS Latitude/Longitude	
				Start	End
Item	Vegetation			38.109639 °	38.110234 °
				-121.159565 °	-121.152330 °
DWR ID	DWR_NA0017_14_s_2016_21				
Comment Code					
V1 : Control annual grass and weeds on the levee slopes and easements.					
Inspector Comment

View of the vegetation on the waterside of the levee.

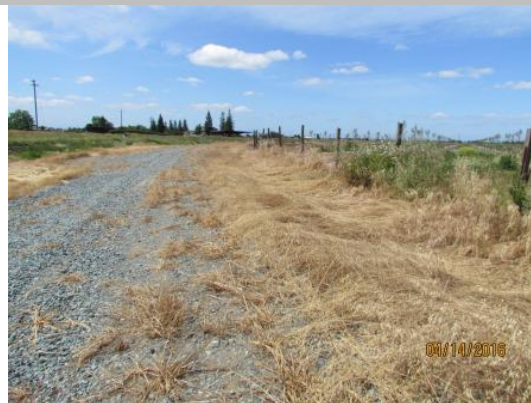
Photo 1 of 1 : SP_2016_NA0017_158_20_20160418_00039.jpg

LM Start	0.04	Rating **	M	Issue No.	20
LM End	0.44	Issue Type +	Ma	Location *	LS
Category	Earthen Levee			GPS Latitude/Longitude	
				Start	End
Item	Vegetation			38.109639 °	38.110245 °
				-121.159454 °	-121.152316 °
DWR ID	DWR_NA0017_14_s_2016_20				
Comment Code					
V1 : Control annual grass and weeds on the levee slopes and easements.					
Inspector Comment

View of the vegetation on the landside of the levee.

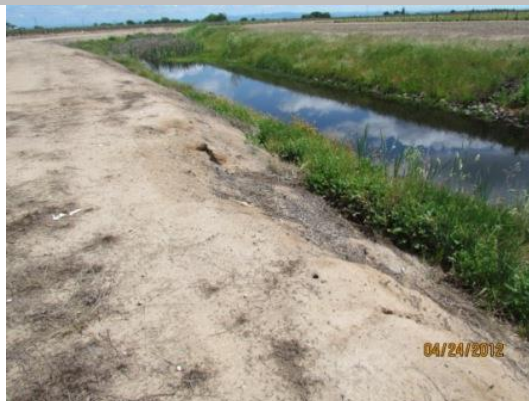
Photo 1 of 2 : SP_2016_NA0017_158_4_20160219_00004.jpg

LM Start	0.60	Rating **	M	Issue No.	4 (cont)
LM End	0.60	Issue Type +	Ma	Location *	WS

View of erosion that was found on the waterside of the levee looking upstream. This picture was taken during spring 2012 inspection.
